Landslides
 DOI 10.1007/s10346-020-01609-x
 Received: 6 May 2020
 Accepted: 10 December 2020
 © The Author(s) 2021

Movements, failure and climatic control of the Veslemannen rockslide, Western Norway

Abstract On September 5, 2019, the Veslemannen unstable rock slope (54,000 m³) in Romsdalen, Western Norway, failed catastrophically after 5 years of continuous monitoring. During this period, the rock slope weakened while the precursor movements increased progressively, in particular from 2017. Measured displacement prior to the failure was around 19 m in the upper parts of the instability and 4–5 m in the toe area. The pre-failure movements were usually associated with precipitation events, where peak velocities occurred 2–12 h after maximum precipitation. This indicates that the pore-water pressure in the sliding zones had a large influence on the slope stability. The sensitivity to rainfall increased greatly from spring to autumn suggesting a thermal control on the pore-water pressure. Transient modelling of temperatures suggests near permafrost conditions, and deep seasonal frost was certainly present. We propose that a frozen surface layer prevented water percolation to the sli

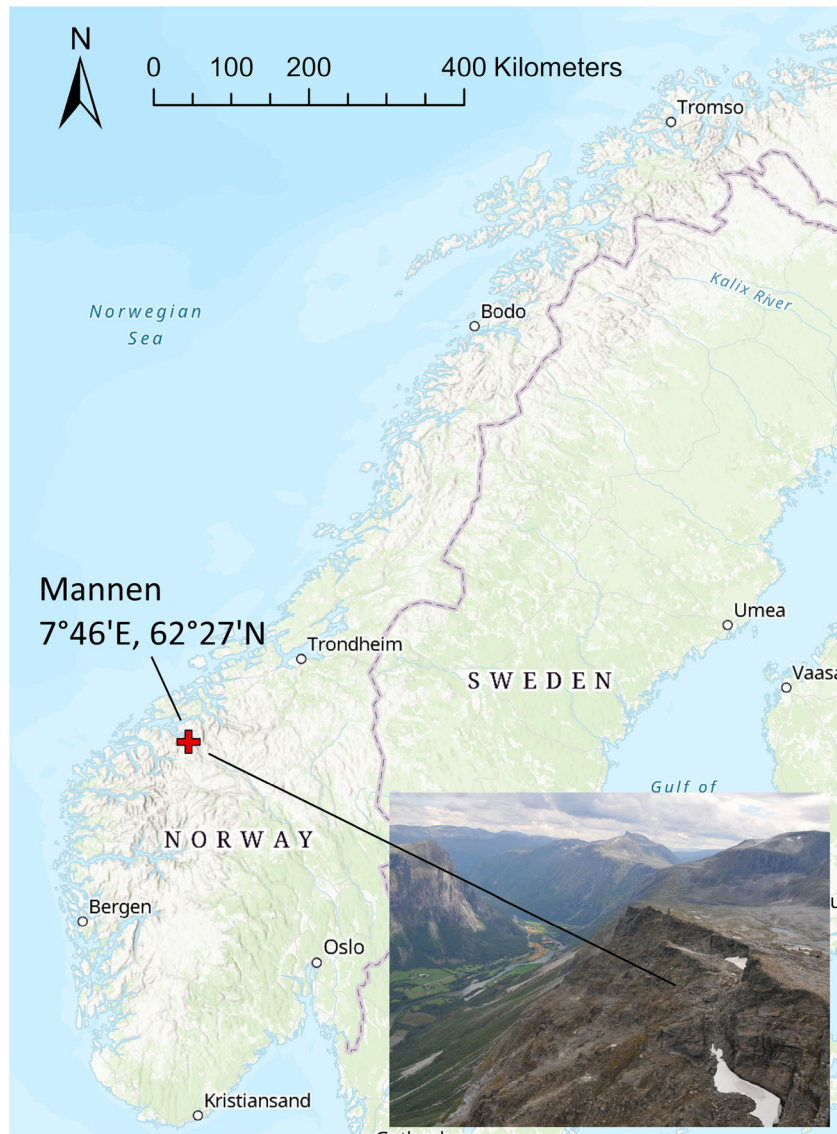
Fig. 1 The location of the Mannen rockslide in Western Norway. Inset: A photo of Romsdalen with the location of Mannen

The *Veslemannen* unstable rock slope was situated on a north-facing slope of Romsdalen, Rauma Municipality, Western Norway. Romsdalen is a 30-km-long over-deepened U-shaped glacial valley cut into the crystalline basement of the Western Gneiss Region, which was metamorphosed during the Caledonian orogeny (Fig. 1). Thinning of the ice sheet began around 15–13 ka, while a valley glacier extending to the fjord existed during the Younger Dryas (Hughes et al. 2016).

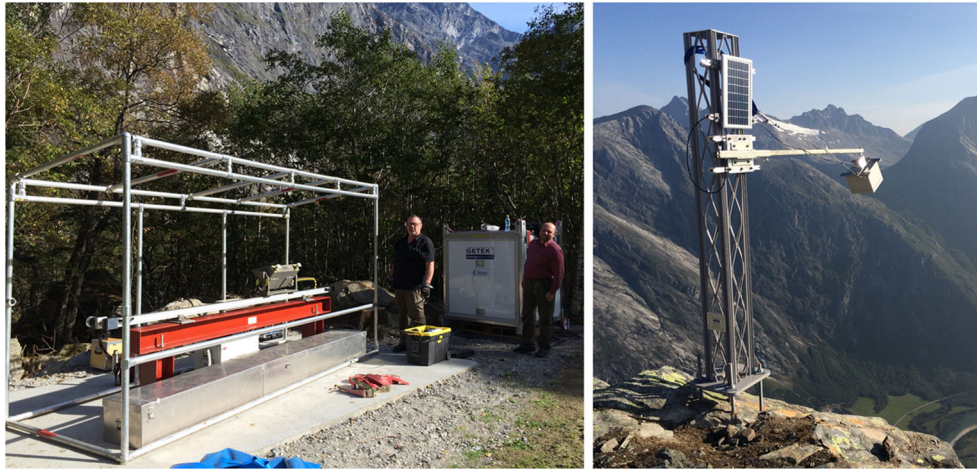
Fig. 4 The GB InSAR system before a permanent hut was built, and a time-lapse camera at the edge of Romsdalen, looking down at Veslemannen

model (DEM). Time series of displacement or speed for selected pixels were analyzed. The movement is measured in the line of sight (LOS), which is assumed close to the direction of movement in the case of Veslemannen. The radar was continuously operated from October 6, 2014, from the valley floor at Lyngheim (Fig. 4, location Fig. 2).

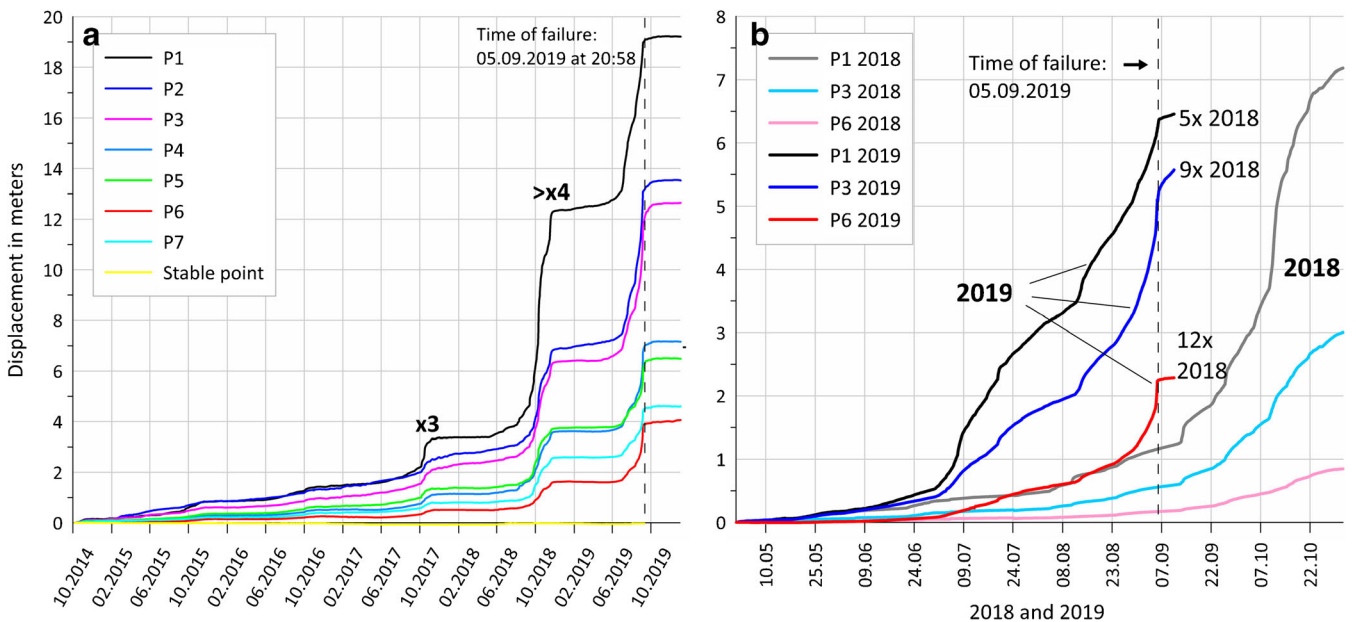
Fig. 6 a Cumulated movement in radar points from 2014 to the failure. b Comparison of the movement in selected radar points in 2018 and 2019

The displacements in Veslemannen prior to 2014 are unknown, but the deformation probably started much earlier. From October 2014 to the failure in 2019, the total displacement in Veslemannen was up to 19 m in the upper parts and 4–5 m in the toe area (time series in Fig. 6a and location of the points in Fig. 7). Typically, movements started slowly in June and increased until around October when freezing conditions set in, and very little displacement was measured during winter seasons. The cumulated displacement on an annual basis was approximately similar during 2014, 2015, and 2016, with about 0.8 m in the upper part and 0.1 m in the toe area. The movement tripled in 2017 (1.9 m in the upper part and 0.26 m in the toe area) and more than quadrupled in 2018 (9 m in the upper part and 1.2 m in the toe area). At the date of failure, displacement in 2019 was 5 to 12 times higher than at the same date in 2018 (Fig. 6b).

displacement increased drastically from year to year (Fig. 6), clearly indicating a progressive damage and weakening.

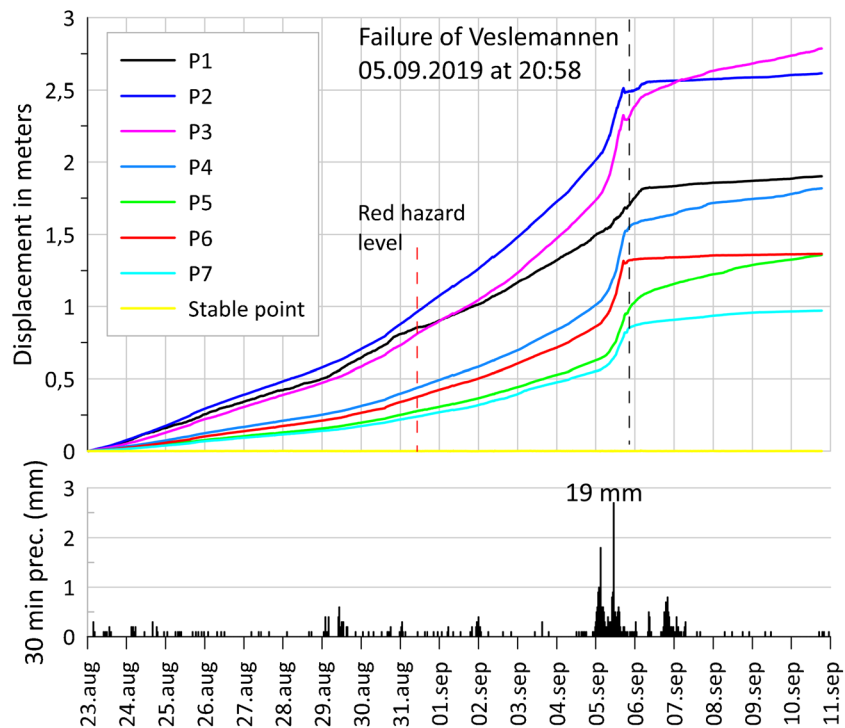
Fig. 10 Cumulated movement and precipitation from August 23 to September 11

A slow acceleration of the rock slope was observed from around August 23, 2019, which was not related to rain or snowmelt (Fig. 10). At midnight on September 5, 2019 (the night before the failure), a rainfall set in, and about 19 mm of rain was measured from midnight to around 15:00. This caused a sharp acceleration, overprinting the ongoing acceleration. Figure 11 shows that the acceleration took place in three distinct steps, at 06:00, 10:30, and

The gentle acceleration that started on August 23, 2019 (Fig. 10) was not triggered by rain. This acceleration caused NVE to change the hazard level from yellow to orange on August 28 and further increase to red hazard level on August 31. The railroad remained open, with a special routine where the police, the train driver, and NVE were on a conference call during each train passage allowing for careful monitoring of the slope during the passages. From the afternoon on September 4, the railroad was closed.

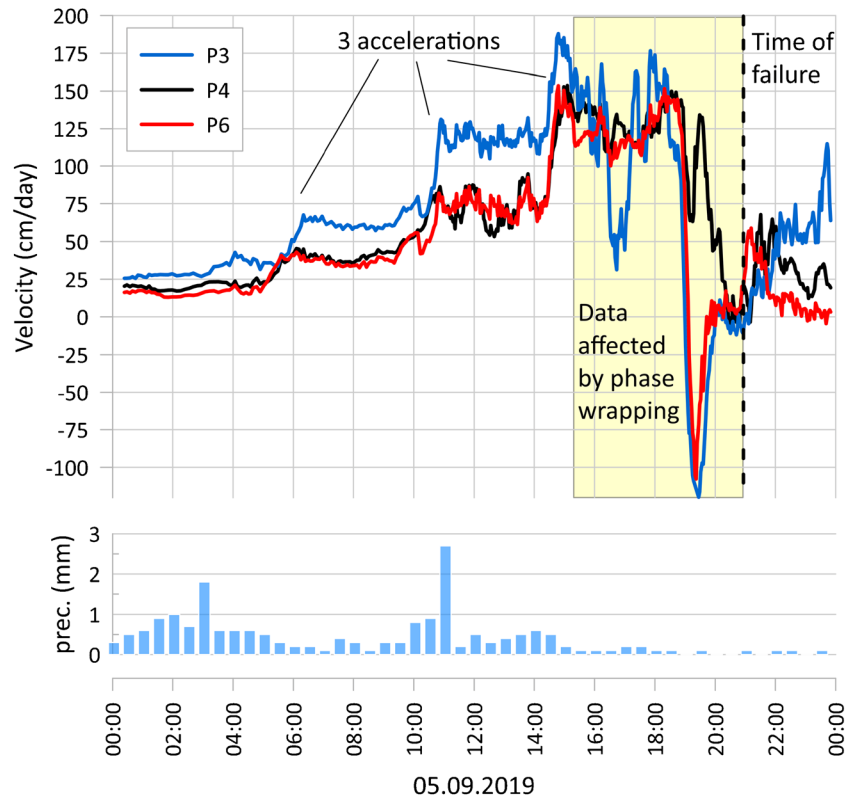
Fig. 11 Velocities and precipitation from three selected radar points at the day of the failure

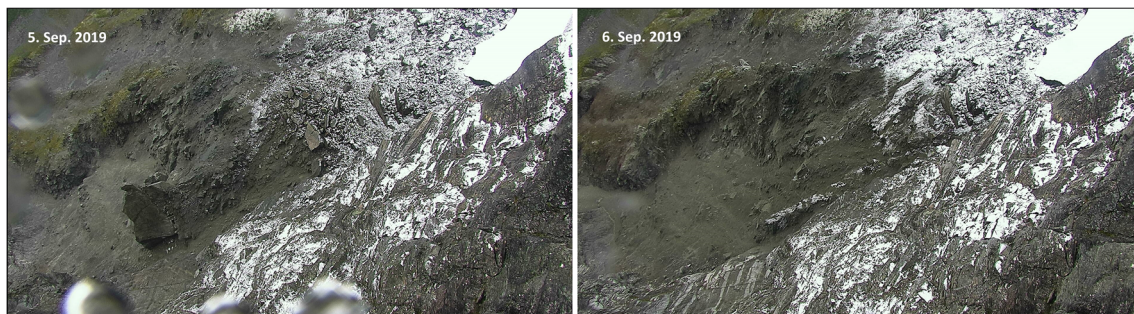
Fig. 12 Photos from the Axis camera looking down at Veslemannen from before and after the failure

occurred almost continuously, but the activity slowed down as it became colder. Figure 12 shows the Veslemannen area before and after the failure.

Unfavourable pre-existing geological structures were probably the main reason why the failure did not occur earlier, despite the large displacement rates. At Veslemannen, the foliation dips steeply into the slope and no favourable outgoing sliding planes were observed. In the detailed structural analysis of Mannen, Saintot et al. (2011) did not observe a clear sliding surface and proposed that several moderate to shallow dipping joint sets guided its development. Our study shows that the final failure was achieved by a progressive weakening of the foot of the rock mass. We observed a rugged exposed sliding surface that does not appear to follow any common structures (Fig. 12).

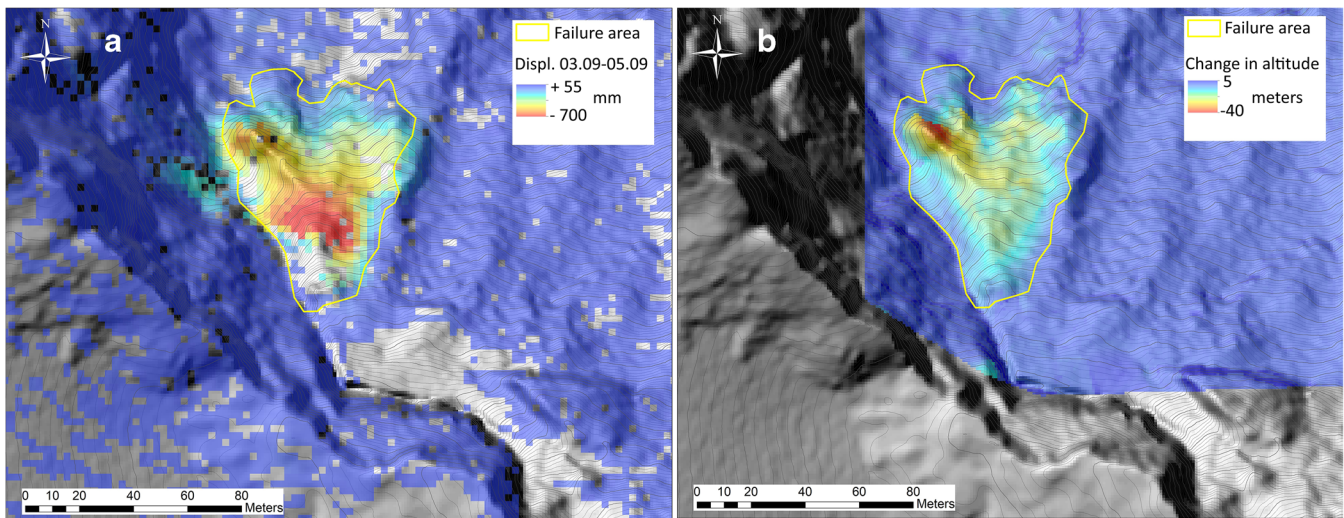
Fig. 13 a Displacements the last 2 days before the failure. b Elevation changes before and after the failure

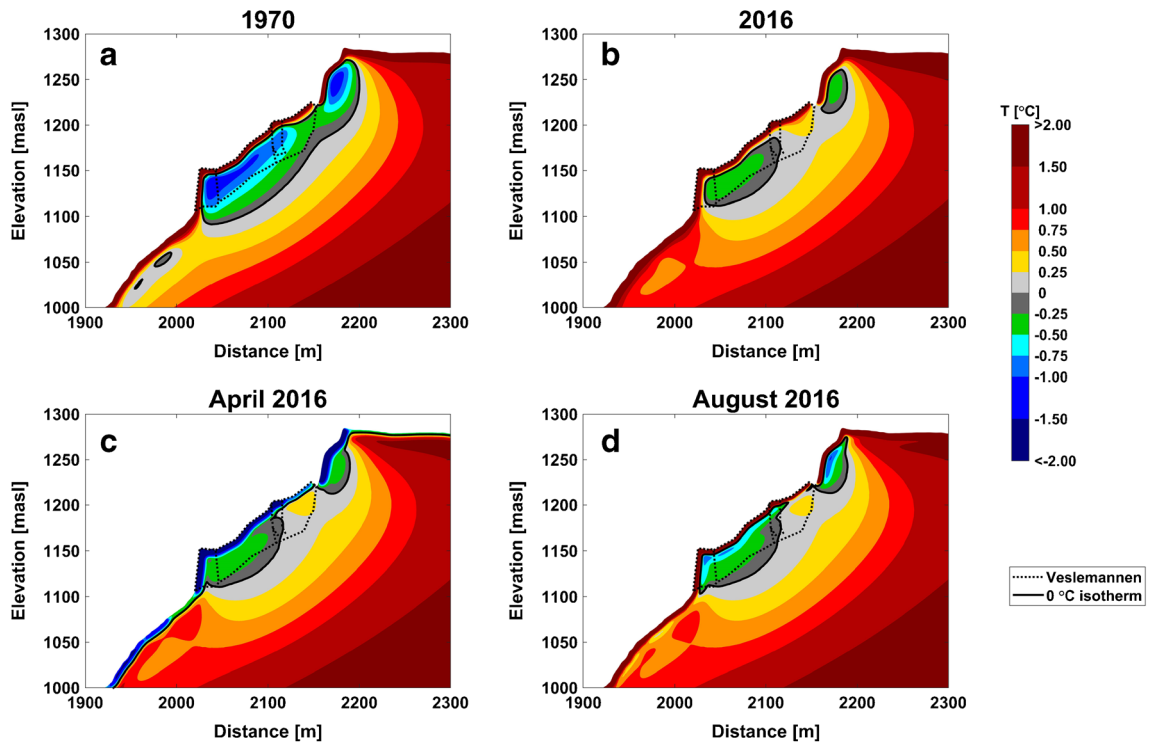
Fig. 15 Ground temperatures modelled for Veslemannen. a maximum temperature in 1970, b maximum temperature in 2016 (around November), c mean temperature in April 2016, and d mean temperature in August 2016

The temperature modelling indicates significant warming in the subsurface of Veslemannen from 1970 to today (Fig. 15 and supplementary material). The model was run on the topography from the 2009 terrain model. As the terrain changed significantly from displacement and rock falls from 2017, we show the modelling results from 2016 as the most recent. Ground temperature warming is especially evident since 2000. In 1970, permafrost was probably present in Veslemannen, while only pockets very close to 0 °C remained in 2016. In 1990, a talik or unfrozen area in the ground is modelled in the middle part at approximately 1210 m a.s.l., where the permafrost body has become decoupled into an upper and a lower colder zone. The colder zones are associated with areas with low snow cover, such as around the lower *Spiret* and the upper steep rock wall, which acted as a “refrigerator” to the ground (Myhra et al. 2017). The instability was subject to deep seasonal frost. Figure 15c shows the temperatures in the coldest period (April), with a thick frozen surface layer, and Fig. 15d shows that even in August, a frozen layer was probably found near the surface of Veslemannen. The warmest subsurface temperatures were modelled to occur around November.

The temperature modelling of Veslemannen was an attempt to approach this issue. Figure 2 and Fig. 15 indicate that Veslemannen was located at a particularly cold section of the slope. From 1970 to 2016, the area warmed considerably, and a layer of year-round unfrozen ground lying in permafrost (*talik*) formed at the upper part of the slope where the failure occurred. The modelled temperatures in 2016 were close to zero ($-0.5\text{ }^{\circ}\text{C}$), so the existence of permafrost at the time of failure was uncertain. No ice was observed at the failure plane at the drone images taken the day after the failure. We propose that recent warming and permafrost degradation could have played a role in the destabilization of Veslemannen, though we are not able to demonstrate a recent increased failure frequency. A feedback mechanism, where increased fracturing allowing more water to percolate and thus heat transfer by advection (not included in the model) and further warming and destabilization, is likely.

What is clear from the model is the deep seasonal frost, as exemplified with temperatures from April and August 2016. Even during August, a frozen zone remains. The bedrock was highly

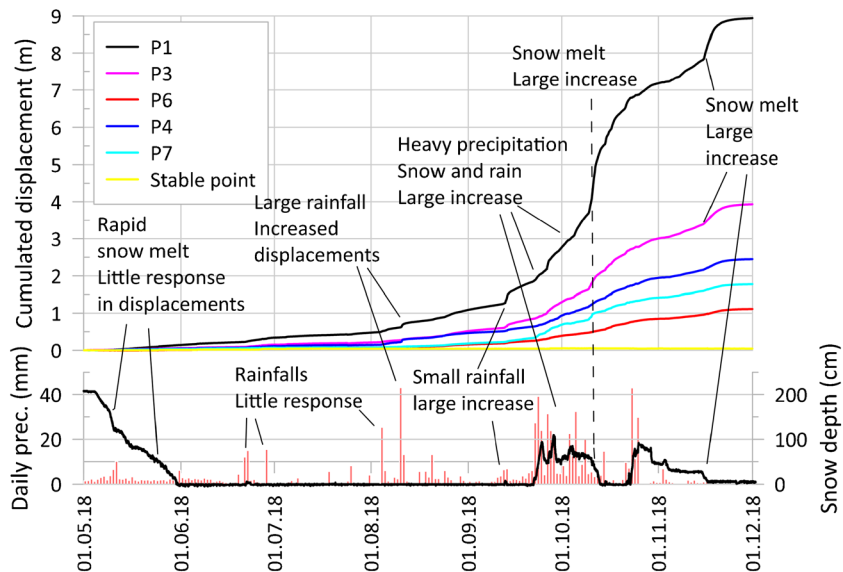
Fig. 16 Cumulated displacement, precipitation, and snow depth from May to December 2018. In 2018, early snowfalls and subsequent melt from September and onwards highly influenced the water supply and displacement rates. The spring snowmelt hardly affected the displacements, while rainfalls or snowmelt late in the season caused large increases in the displacements

A clear trend of increased sensitivity and reaction to precipitation was observed every year from summer to autumn. Even at days of rapid snowmelt, movements in Veslemannen only increased a little during the spring season (Fig. 16). From late summer to autumn, rainfall or melting from an early snowfall would cause a steep acceleration, and the sensitivity to water supply increased each year until around October. This is a type

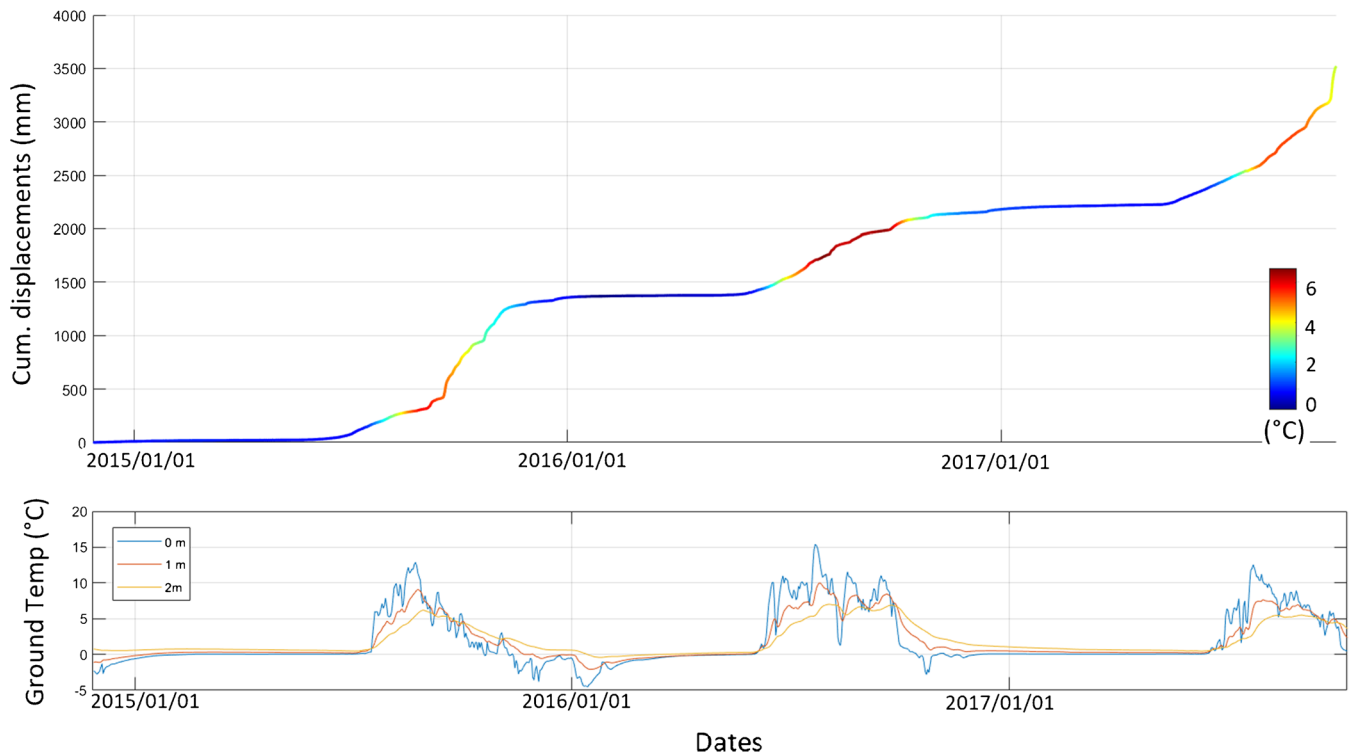
Fig. 17 Upper subplot shows movement from an extensometer where the line colour indicates the temperature in 2 m at the bunker borehole. The lower subplot shows borehole temperatures at 0, 1, and 2 m depth

of time-varying effect, where the response to the driver varies with the season (Abellan et al. 2017). The sensitivity is related to ground temperatures as indicated in Fig. 17, and we hypothesise a thermal mechanism for the observed time-dependent slope sensitivity to rainfall.

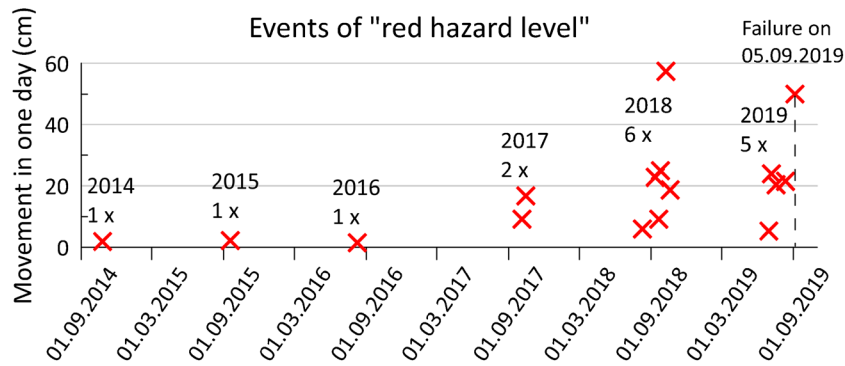
Fig. 18 All reported red hazard levels from 2014 to 2019. The maximum daily displacement measured at radar point 1 during each event is shown on the Y-axis. The movement on the final day is very much underestimated, as phase wrapping in the upper slope affected the radar signal most of this day. Most of the events occurred in autumn, though in 2018 and 2019, the accelerations started earlier

the weather forecast was used when setting the hazard level, to avoid evacuations during night-time. The management and the burden on the evacuated residents became difficult, as a total of 16 evacuations were undertaken. A time series plot of the 16 reported red hazard levels is shown in Fig. 18.

Important aspects and behaviour of the slopes were learned along the way. Decision-making is required while key elements in the geological understanding are probably missing and may be difficult or impossible to obtain. For Veslemannen, the velocity threshold values used for setting appropriate hazard levels were adjusted at least annually and were typically increased. With experience, our focus shifted from displacements measured in the upper part to the controlling toe area of the instability when evaluating the slope. Despite significant increases in threshold values, the ever-increasing velocities caused many evacuations in 2018 and 2019 (Fig. 18).

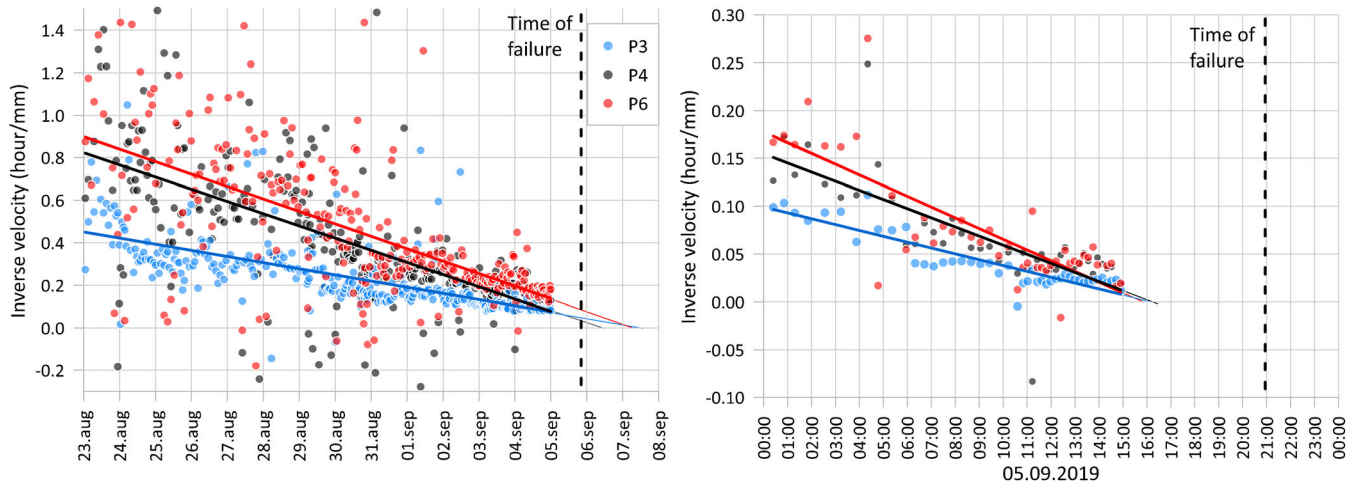
Fig. 19 Inverse velocity plots for selected radar points, where P3 is in the upper part of the slope and P6 is at the toe area. The first plot starts on August 23 and stops when the rain-induced additional acceleration starts (September 5 at midnight). The second plot starts at midnight on September 5 and ends at 15:00 h, where consistent phase wrapping started. Velocities from averages of five GB InSAR images were used to reduce the noise. Linear regression lines are shown and extrapolated to 0 on the Y-axis

Plotting inverse velocity in the final stage was used more frequently, though still not used as a criterion for setting the hazard levels. Two inverse velocity plots with different time intervals (selected after the event) are shown in Fig. 19. The estimated failure times and correlation coefficient for the two inverse velocity plots are listed in Table 2.

The inverse velocity plot for the first acceleration points to a failure 12–42 h later than when it occurred. For the rain-induced acceleration on September 5, the extrapolation for all three points indicates a failure time around 16:00 the same day, 5 h before it happened. We assume that both indicated times of failure were credible and the discrepancies are a result of changes in basal conditions caused by the rainfall on the day of the failure. This suggests that the failure was most likely imminent regardless of the rainfall on September 5, but that the rainfall forwarded the event a little. As the driving mechanism towards the final failure was reduced when it stopped raining, the failure was slightly delayed. The selected points show a similar pattern, though the noise level is higher for P6 (toe area) as the velocities here were lower than higher in the slope. As we interpret the toe as the controlling part, where breakage of rock bridges was required for the failure to occur, the use of the inverse velocity method should probably focus on this part. Failure forecasting in real time using the inverse velocity model is not always straight-forward, though in retrospect it may be easy to fit a line to the data points pointing to the time of failure.
